### RESIDENTIAL REPORT

1234 Main Street Mukilteo, WA 98275

Inspector
TREVOR RIPPON
+15096906307
visionaryinspectionservices@outlook.com

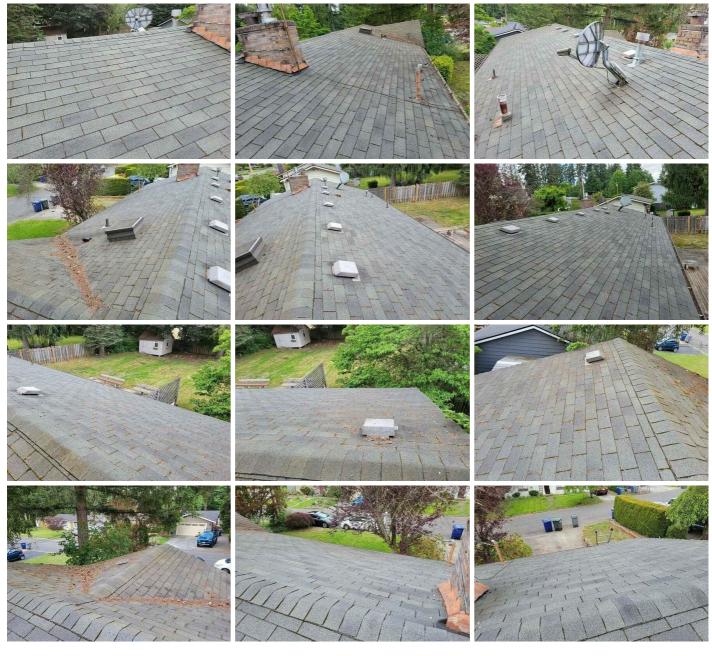
**General Photos**

Roof Type/Style
Gable

**Coverings: Material**Asphalt

Roof Drainage Systems: Gutter Material Aluminum

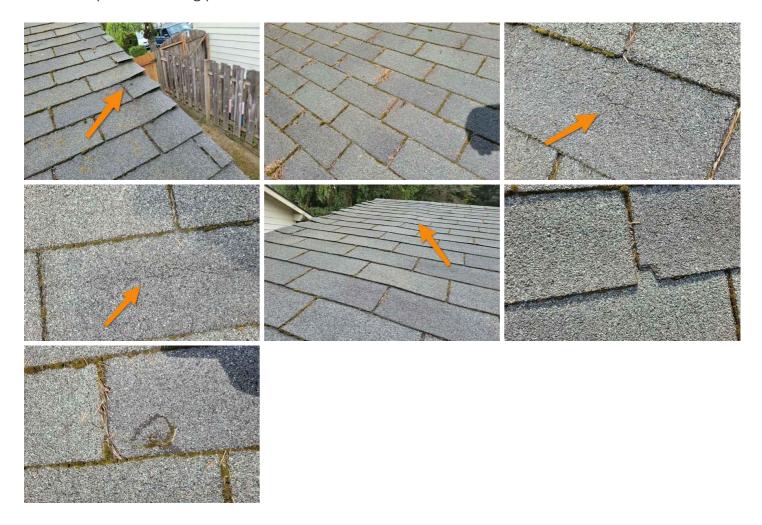
#### **DAMAGED (GENERAL)**

Roof coverings showed moderate damage. Recommend a qualified roofing professional evaluate and repair.

**As seen in following images**: Lifted shingles, broken edges, general cracking, bio growth around edges of shingles, and debris covering roof.

Contact a qualified roofing professional.

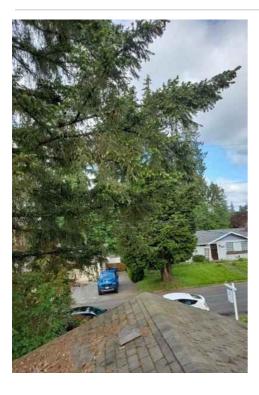
#### TREE OVERHANGING ROOF

Trees overhanging roofing material can lead to debris accumulation, sap damage, moisture retention, animal access, storm hazards and more. Recommending trimming sections overhanging roof

Contact a qualified tree service company.

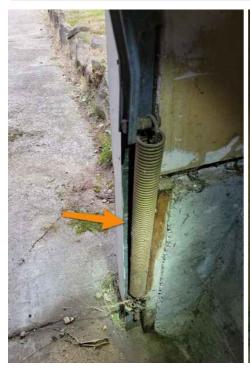
#### **RUSTED TENSION SPRINGS**

Garage Door Tension Spring(s) Rusted - Recommend Replace for increased safety.

Contact a qualified garage door contractor.

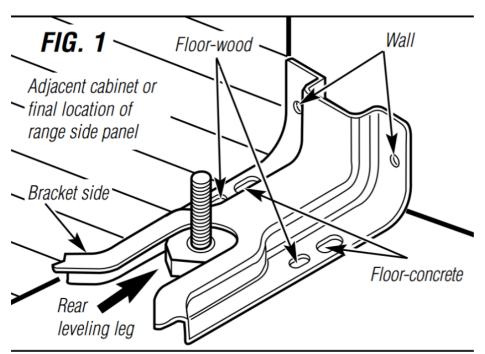
Prevents Tipping: The primary purpose of an anti-tip bracket is to prevent the appliance from tipping over. If a heavy object, such as a pot or a person, leans on an open oven door, it can cause the stove or oven to tip forward, leading to potential injuries or accidents.

Child Safety: In homes with children, the anti-tip bracket provides an added layer of safety. It helps prevent children from climbing on the oven door or pulling on the stove, which could cause it to tip over.

Contact a qualified appliance repair professional.

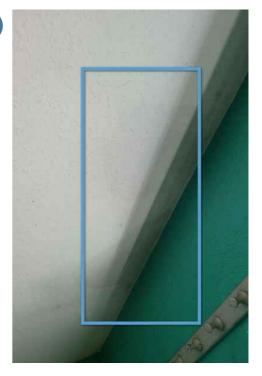
8.2.2 Floors, Walls, Ceiling

#### **FUNGAL GROWTH**

Residue appears fungal in nature. I did not inspect, test or determine if this growth is or is not a health hazard. this type of testing is beyond the scope of a standard home inspection. The underlying cause is likely moisture or dampness. No obvious elevated moisture at the time of inspection. I recommend a qualified specialist to evaluate and or repair.

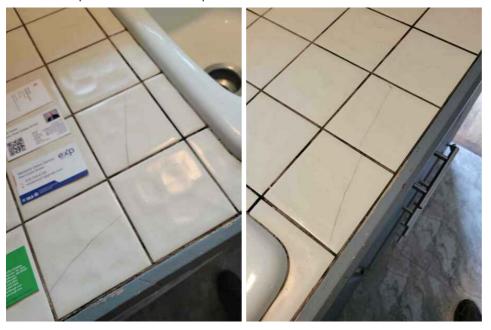
#### **COUNTERTOP CRACKED/CHIPPED**

Countertop had one or more cracks or chips. Recommend qualified countertop contractor evaluate and repair.

Contact a qualified countertop contractor.

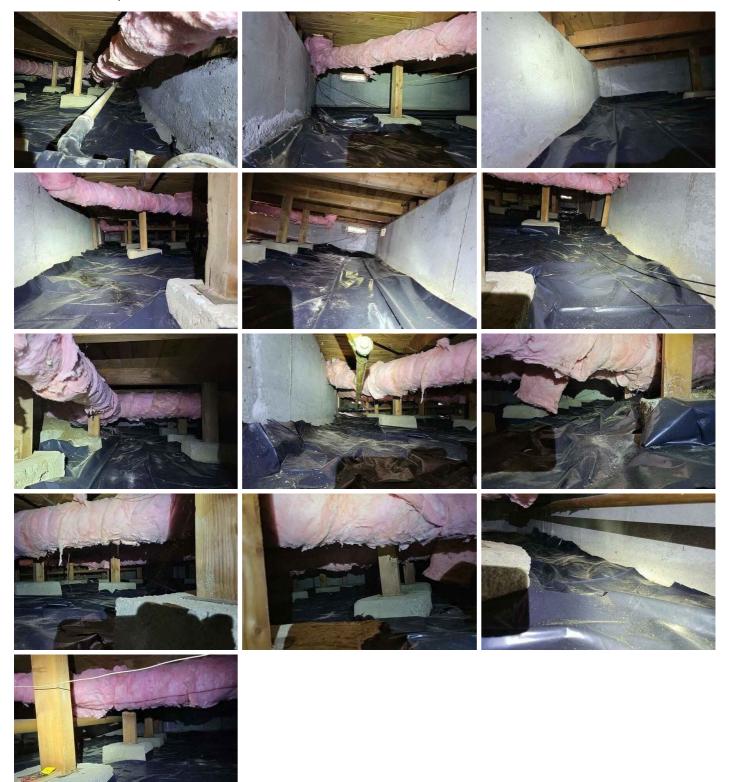
#### **Inspection Method**

Visual, Crawlspace Access

**Foundation: Material** Concrete

Floor Structure: **Basement/Crawlspace Floor** Dirt

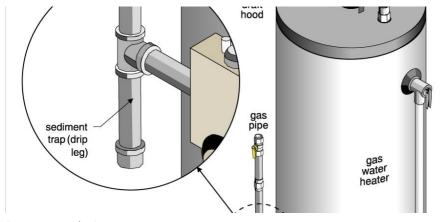
### **GAS LINE(NO SEDIMENT TRAP)**

Missing sediment trap in gas line. A trap is installed to catch any debris which can pose a problem in the orifices of the gas burning appliances. Recommend evaluation and repair by a qualified plumbing contractor or HVAC contractor.
